City of Bend

Stormwater Infiltration Evaluation Update

October 2020

Prepared by:
GSI Water Solutions, Inc.
55 SW Yamhill St., Suite 300, Portland, OR, 97204

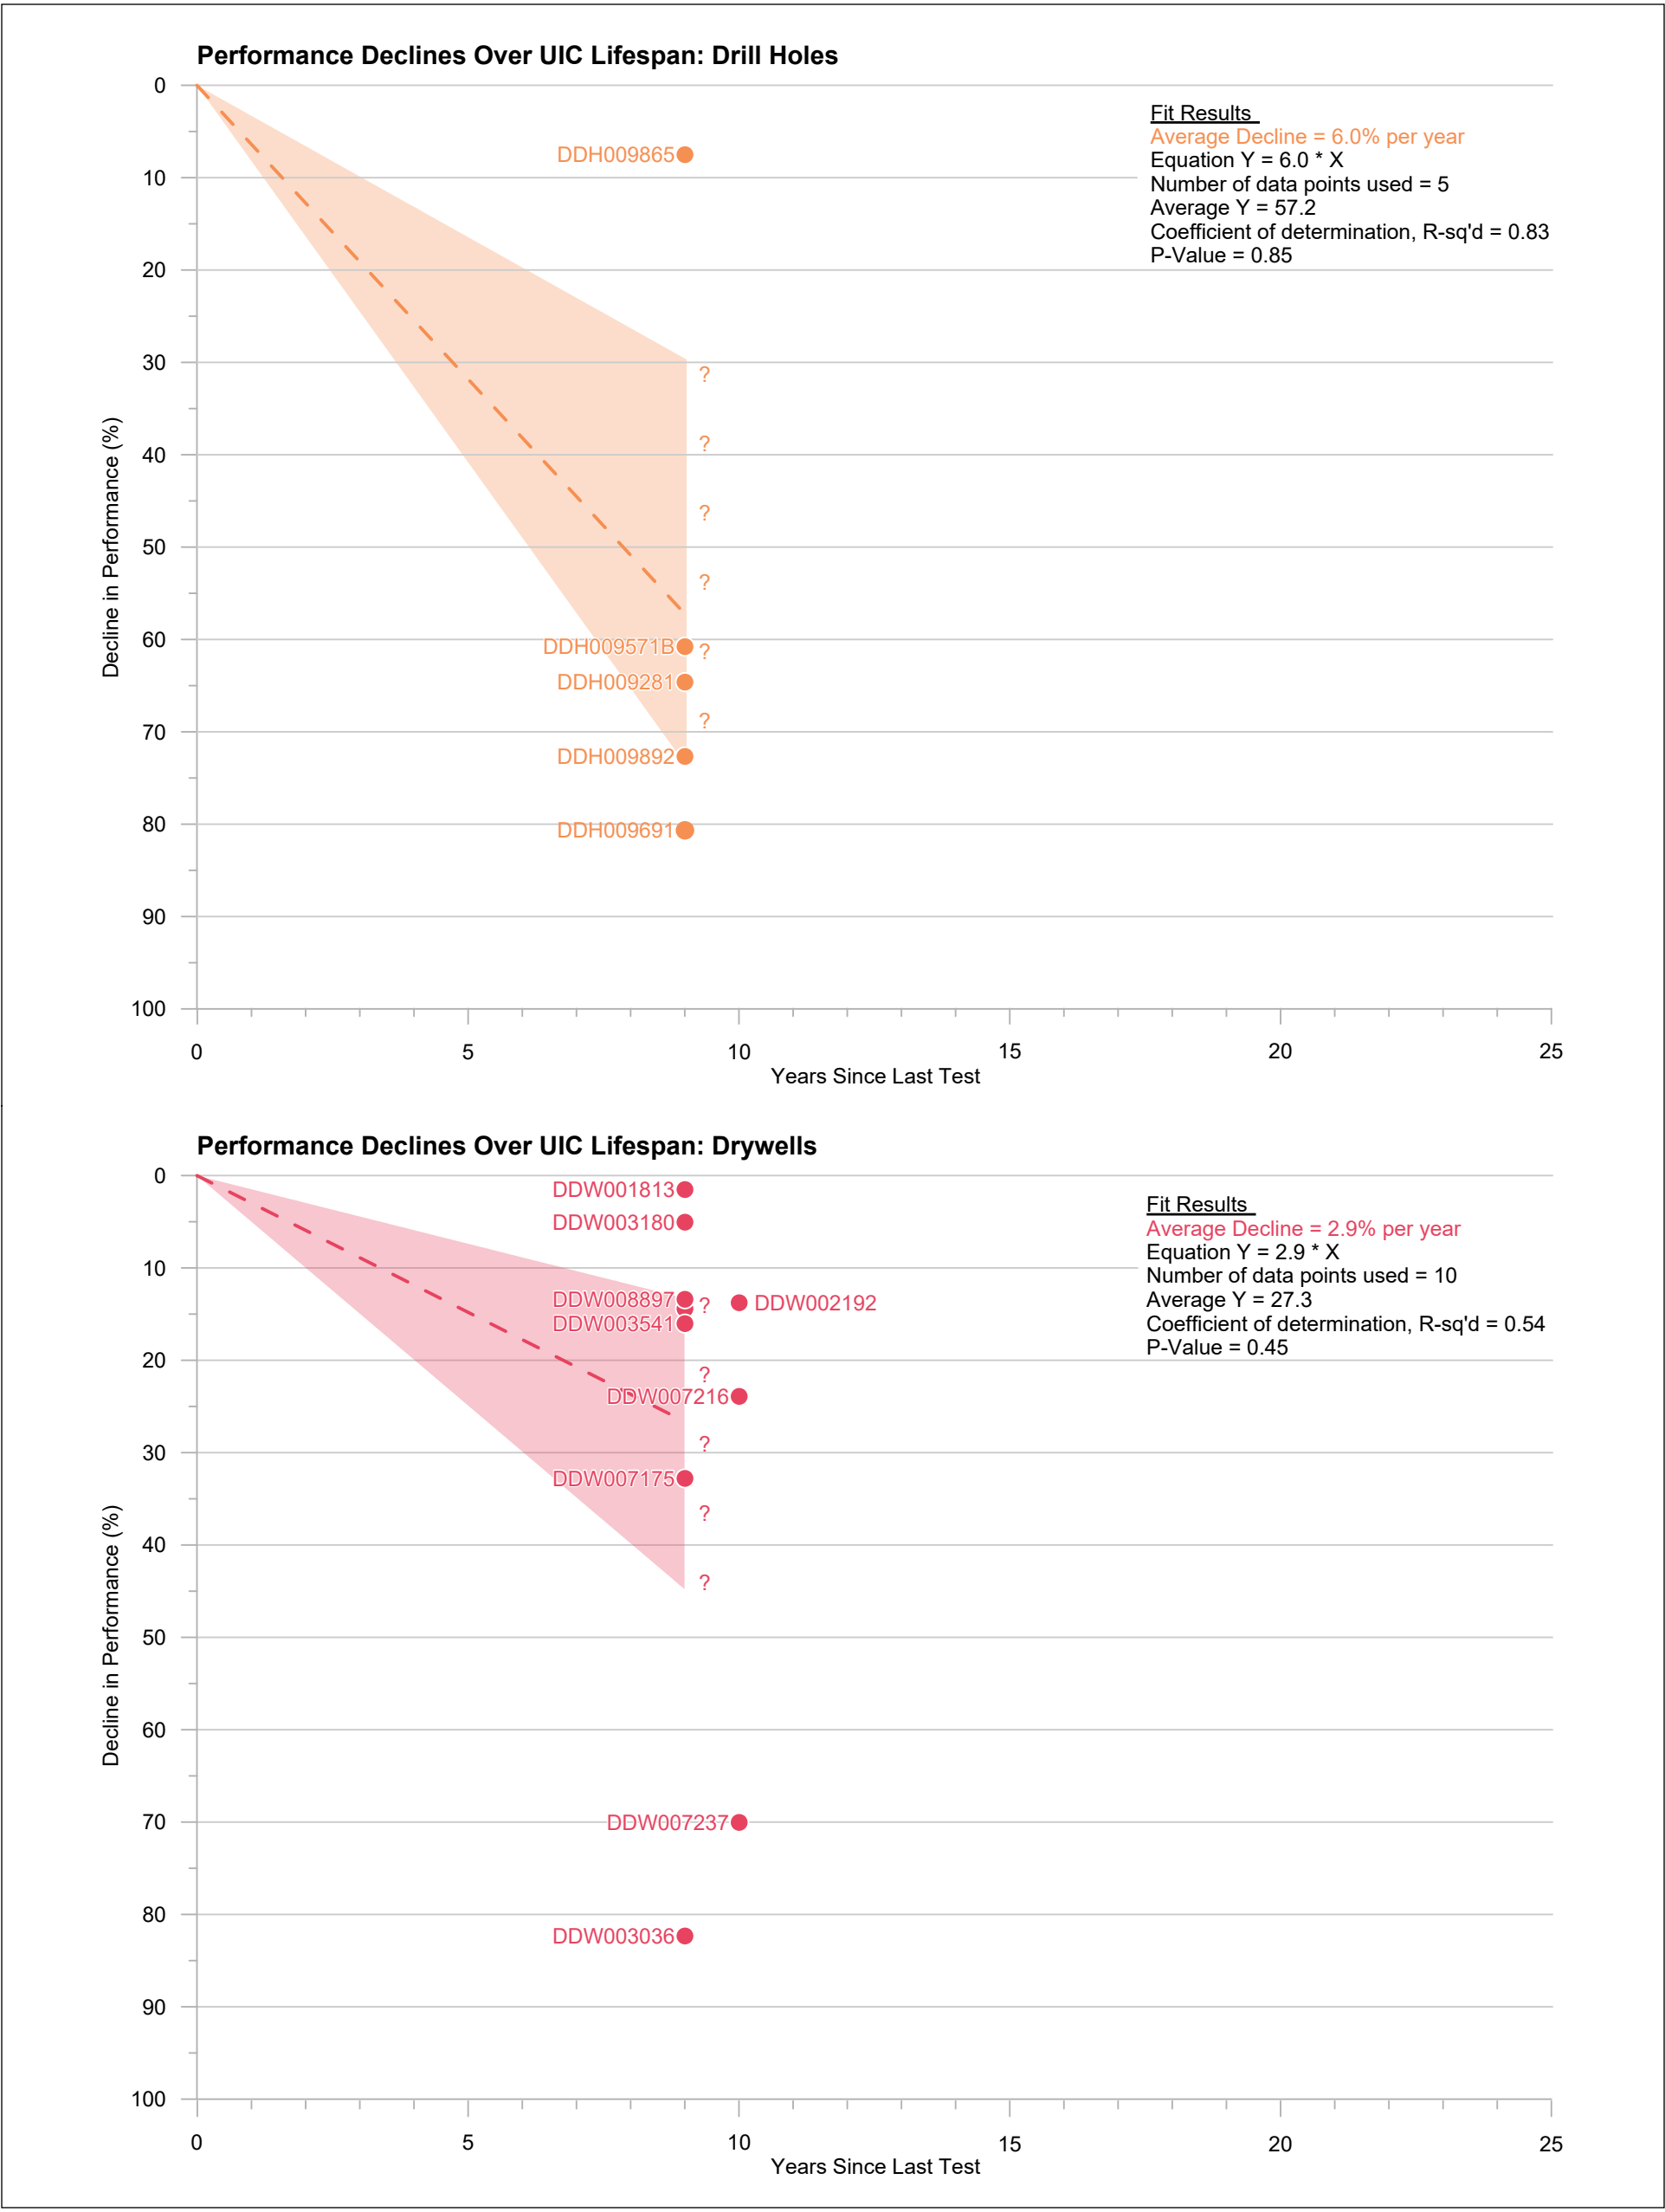
Performance Declines Over Time for Drywells and Drill Holes
 Stormwater Infiltration Evaluation Update

- **Drywells and Drill Holes (Figure 3-2).** As shown on Figure 3-2, drill hole performance declines faster than drywell performance. Specifically, drill hole performance declines generally range from about 60 percent to 80 percent after about 10 years of infiltration, and drywell performance declines generally range from less than a percent to about 30 percent after 10 years of infiltration. This trend is also evidence on an average basis, as drill holes were characterized by average performance declines of 6.0 percent per year based on the regression line in Figure 3-2, while drywells were characterized by average performance declines of 2.9 percent per year based on the regression line in Figure 3-2. The faster ageing of drill holes may be caused by the lower level of pretreatment typically installed at drill holes, or their smaller sidewall area which would make them more susceptible to clogging over time (drill holes are six-inch diameter devices while drywells are typically four-foot diameter devices).

- **Maintenance Activities.** For UIC maintenance, because drill holes appear to age faster than drywells, and because drywells that drain streets with $\geq 1,000$ TPD appear to age faster than drywells that drain streets with $< 1,000$ TPD, we recommend that the City prioritize preventative maintenance activities for UICs on drill holes, and on UICs that drain streets with $\geq 1,000$ TPD.

- **Facility Types.** Drywells are less susceptible to performance declines over time than drill holes. As such, we recommend that the City encourage stormwater management using drywells when feasible at a site. In addition, we recommend prioritizing pretreatment retrofits at drill holes.

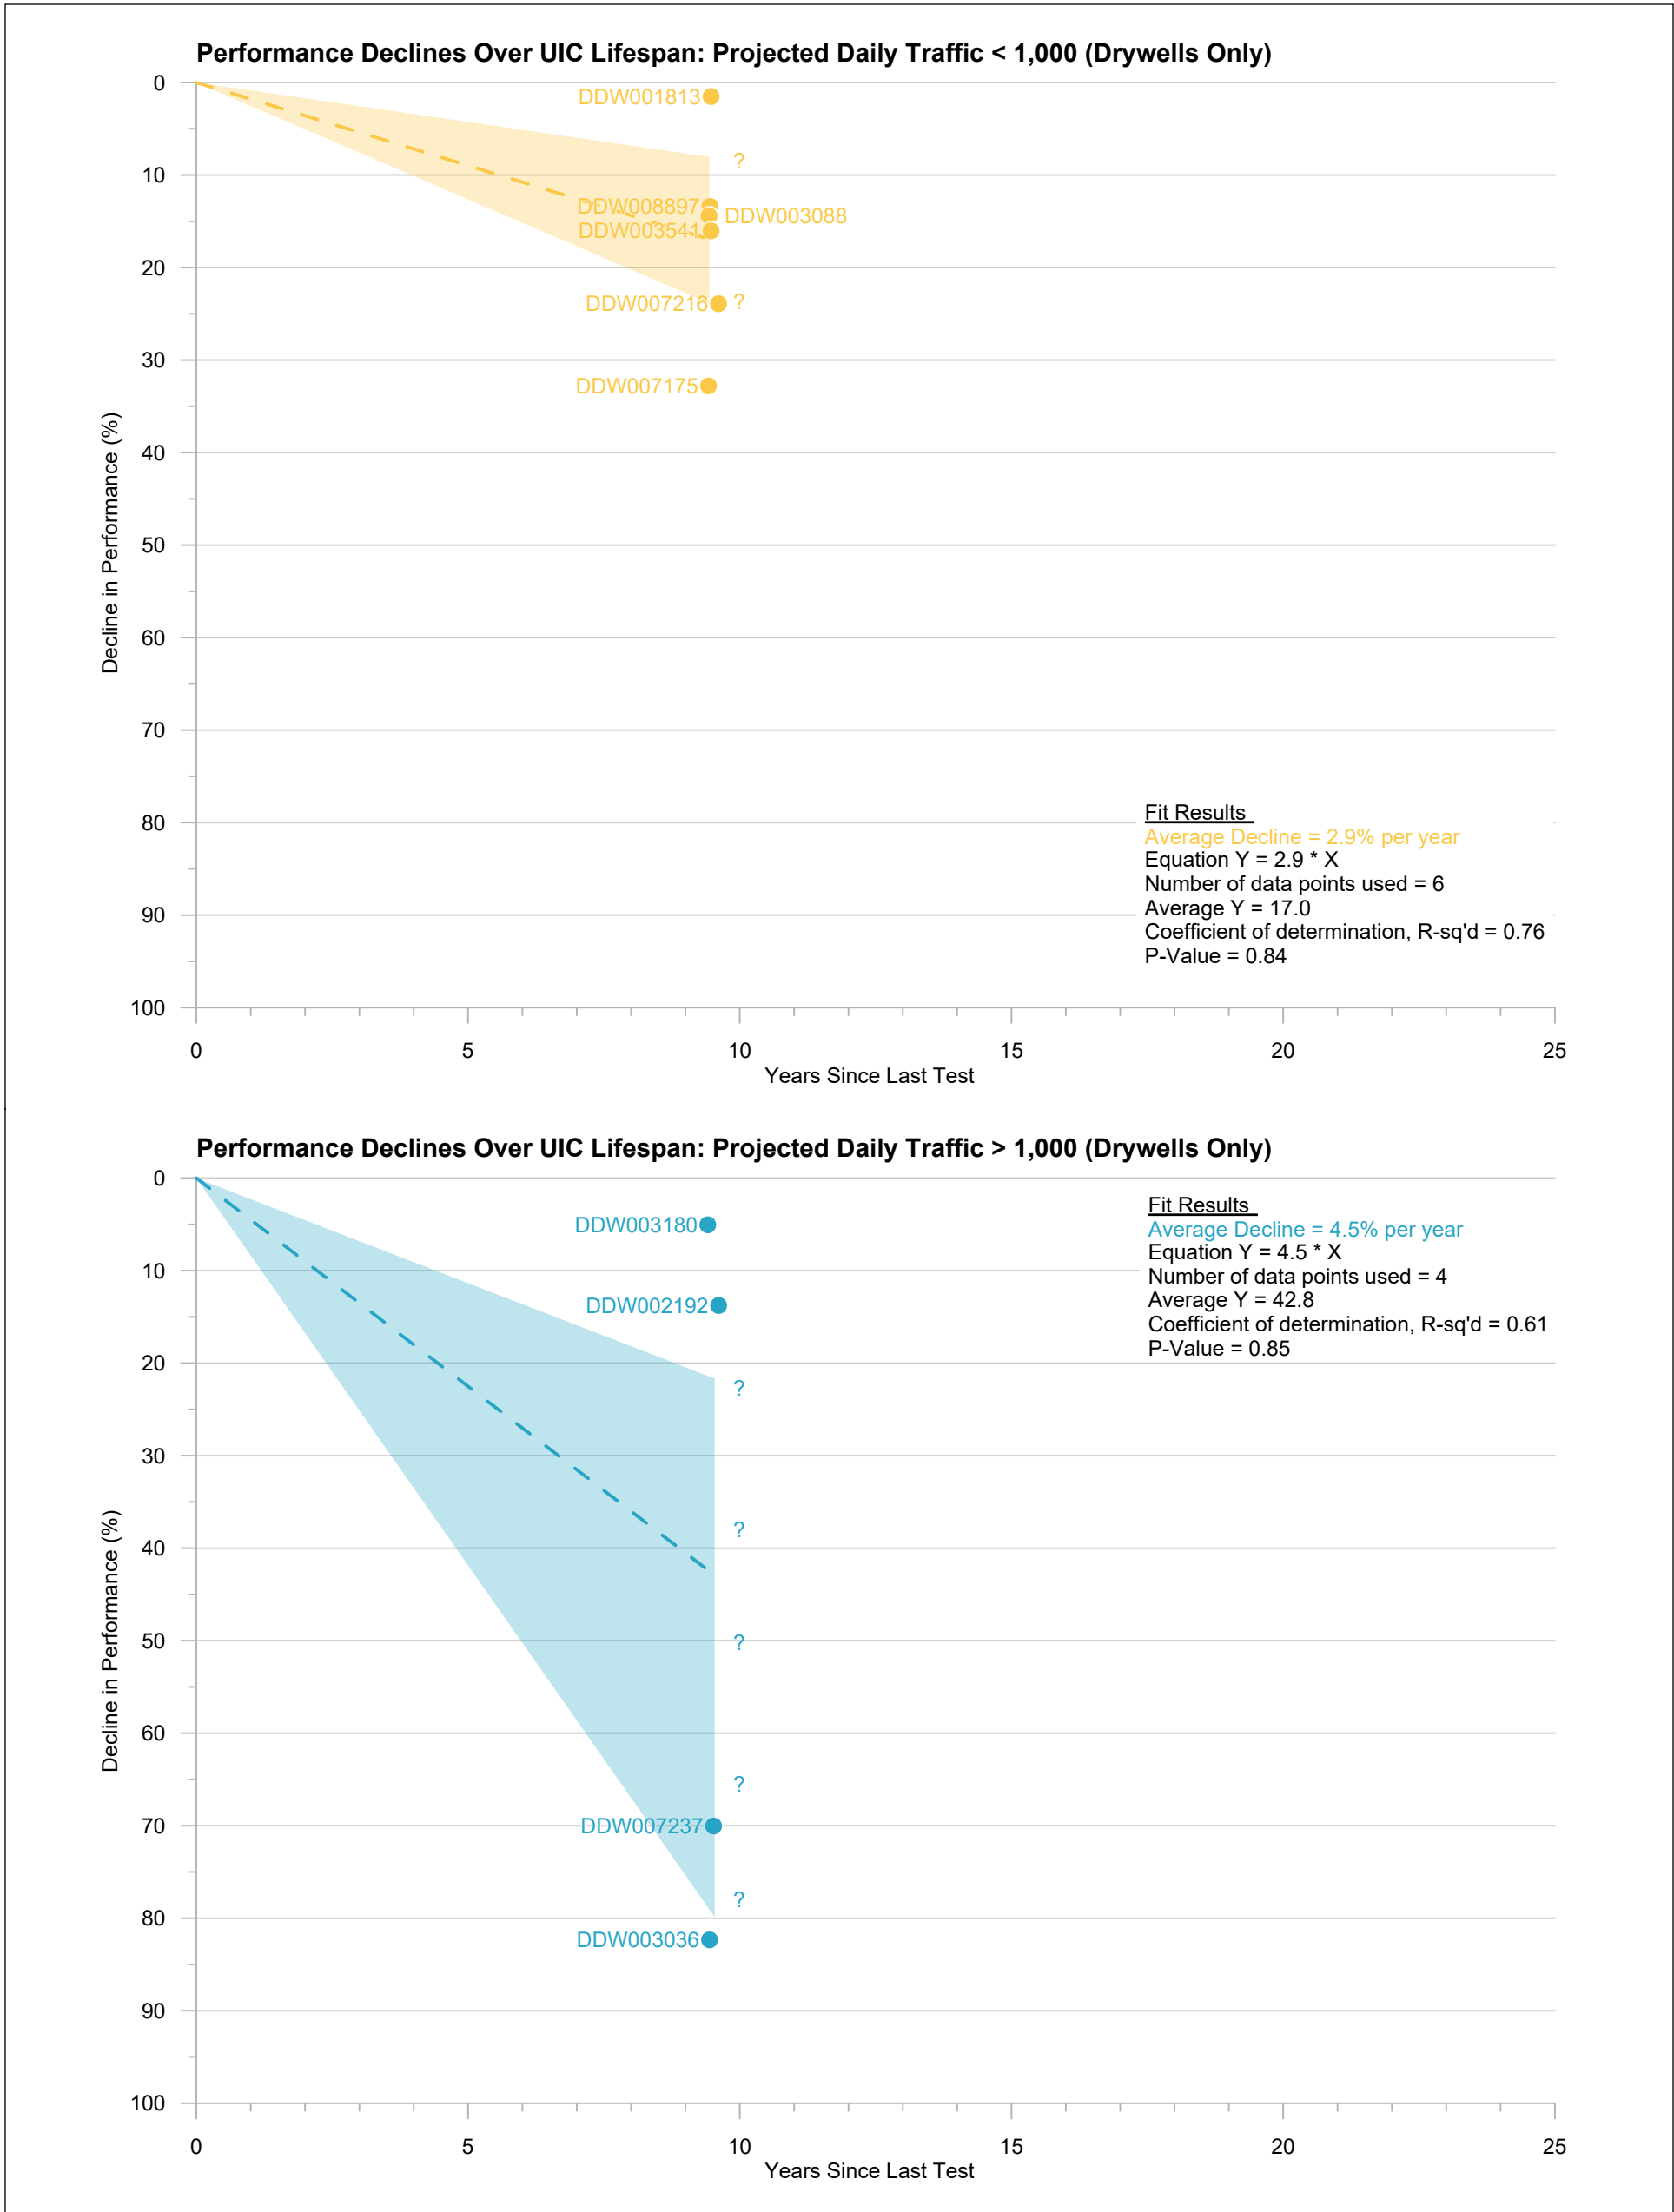
FIGURE 3-4
Performance Declines Over Time for Drywells by Traffic Category
 Stormwater Infiltration Evaluation Update

- Decline in UIC performance calculated using Falling Head infiltration testing data
- UICs that exhibited an increase in performance are not presented
- The calculated confidence intervals are estimates that the population mean for a given x value will fall within the confidence interval; the confidence interval does not mean that for any given UIC, there is a 95% probability that the performance of the UIC will fall within the confidence interval.
- The P-Value indicates the relative significance of the confidence interval's fit; commonly, a P-Value less than 0.05 indicates non-random (significant) results.
